Manhole Inspection Summary

Manhole # S21G1_015MH

Insp Date: **4/13/08 12:45 PM**

Location Address: **2712 hollins ferry rd**

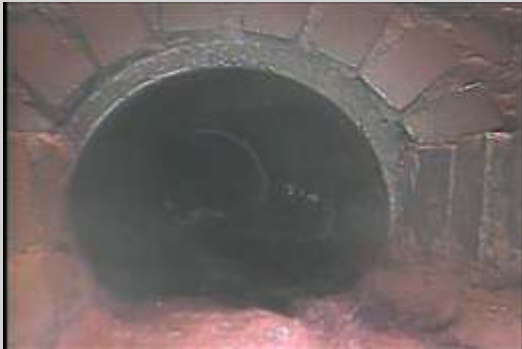
12 O'Clock Outflow

12 in. Circular Gravity Sewer
Pipe Out @ 12 O'Clock

Pipe Height: **12** (in.) Rod and Bar (Angled)
Pipe Material: **Clay** ☐ Pipe Lined
Invert Depth: **12.01** (ft.) Flow Characteristics: **Slow**
Deposits: ☒ None ☐ Mud ☐ Sludge ☐ Debris ☐ Grease
Silt Depth: **0** (in.) Deposits Extent:
Infiltration: **None** Pipe Seal Cond: **Sound**

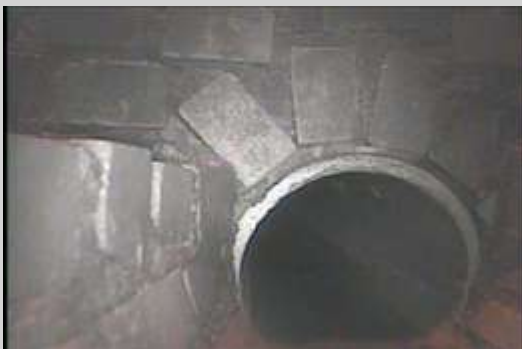
3 O'Clock Inflow

8 in. Circular Gravity Sewer
Pipe In @ 3 O'Clock

Pipe Height: **8.4** (in.) Rod and Bar (Angled)
Pipe Material: **Clay** ☐ Pipe Lined
Invert Depth: **11.90** (ft.) Flow Characteristics: **Slow**
Deposits: ☒ None ☐ Mud ☐ Sludge ☐ Debris ☐ Grease
Silt Depth: **0** (in.) Deposits Extent:
Infiltration: **None** Pipe Seal Cond: **Sound**

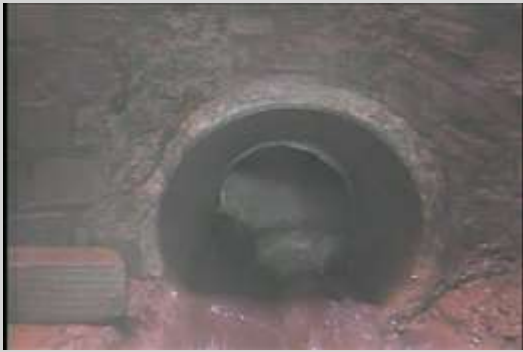
6 O'Clock Inflow

12 in. Circular Gravity Sewer

Pipe In @ 6 O'Clock

Pipe Height: **12** (in.) Rod and Bar (Angled)

Invert Depth: **11.54** (ft.) Flow Characteristics: **Slow**

Infiltration: **None** Pipe Seal Cond: **Sound**

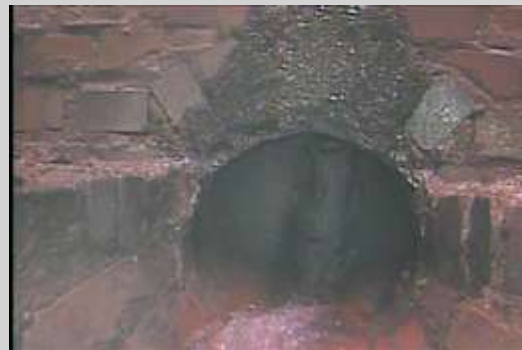
Drop In @ 9 O'Clock

Drop: **Outside** Rod and Bar

Angled: **Yes** Reading: **10.91** (ft.)

Drop Condition: **Open**
